WRDC-TR-89-4055

COMPENDIUM OF FRACTOGRAPHIC DATA FOR COMPOSITE
MATERIALS

INTERIM REPORT
Covering 9-22-86 through 10-31-88

C. Hua
M. Yamashita
Boeing Advanced Systems
P.O. Box 3707
Seattle, WA 98124

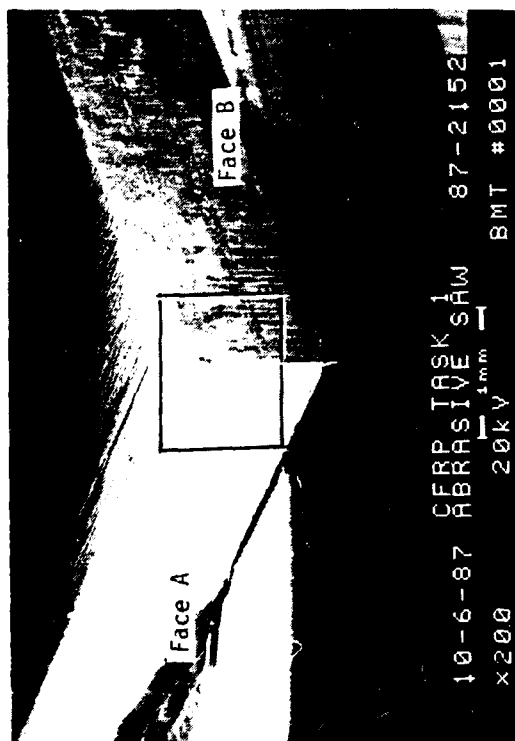
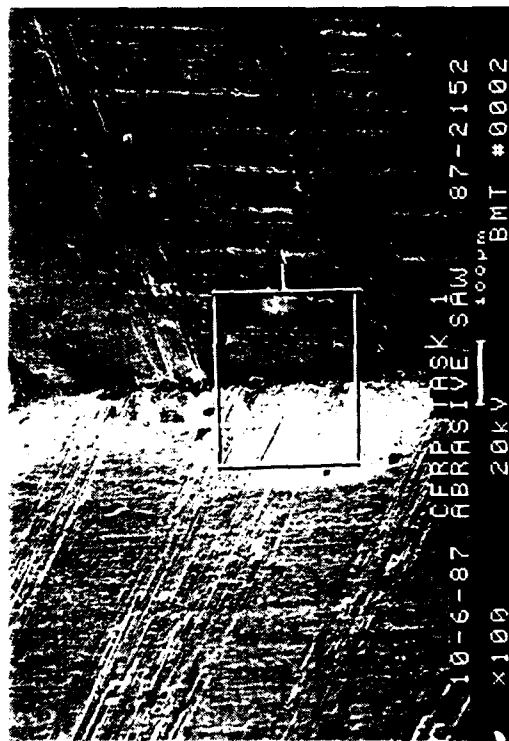
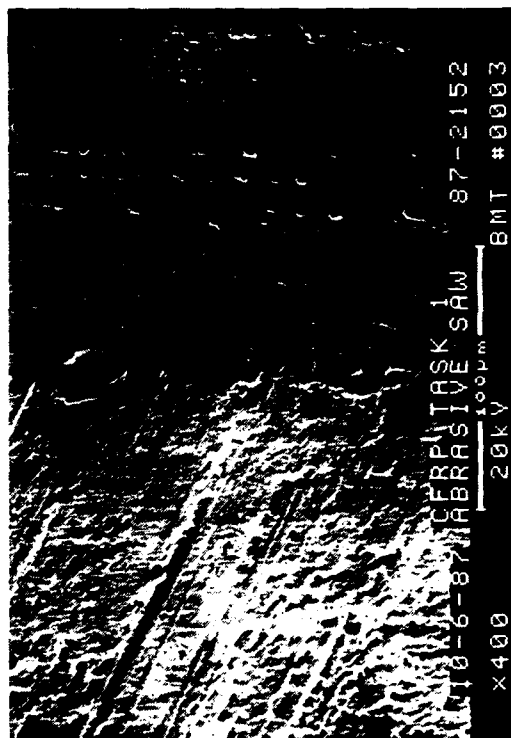
Figure 2.4-20. SEM Fractographs of Abrasive Saw Cut Specimen

Note: Both faces A and B are abrasive saw cut

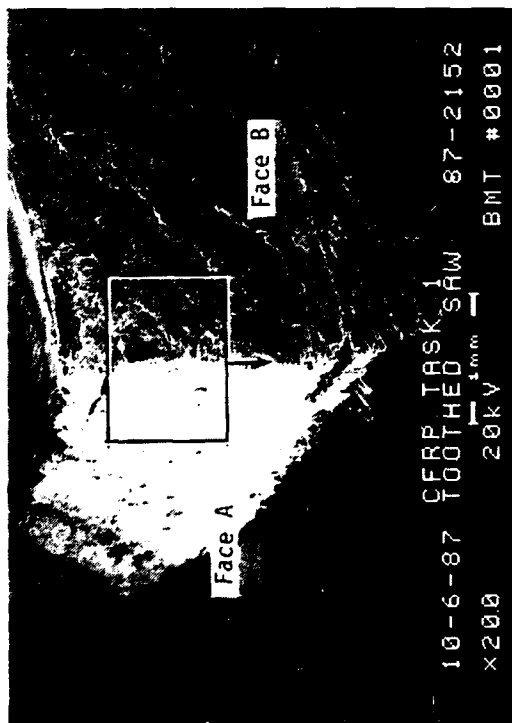
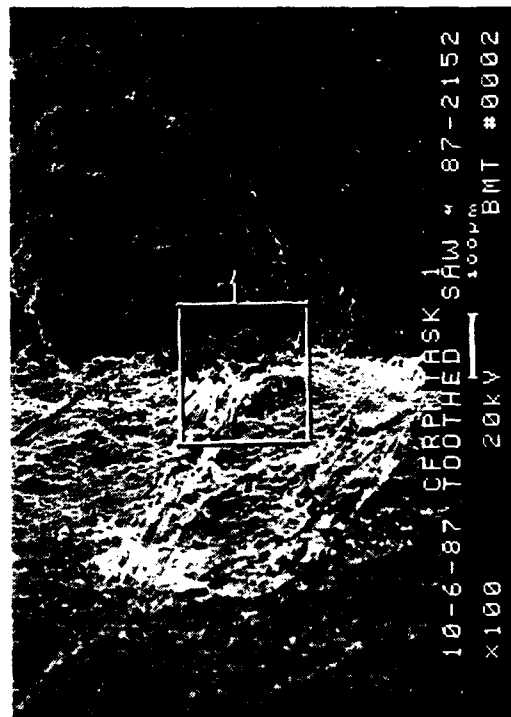
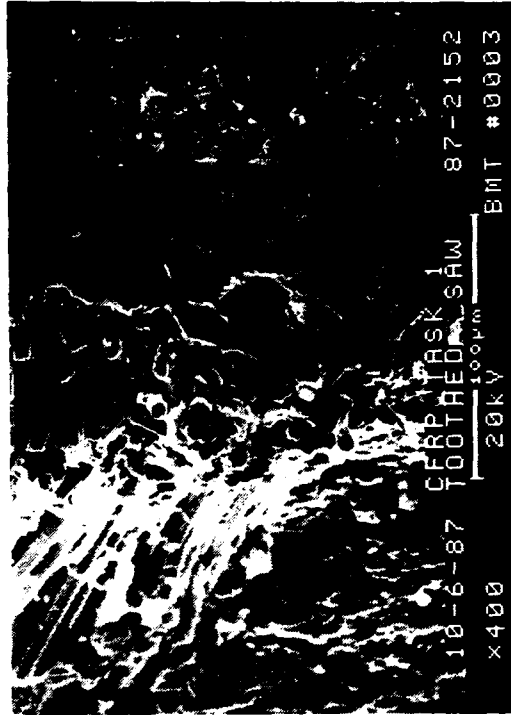
Figure 2.4-21. SEM Fractographs of Toothed Saw Cut Specimen

Note: Both faces A and B are toothed saw cut

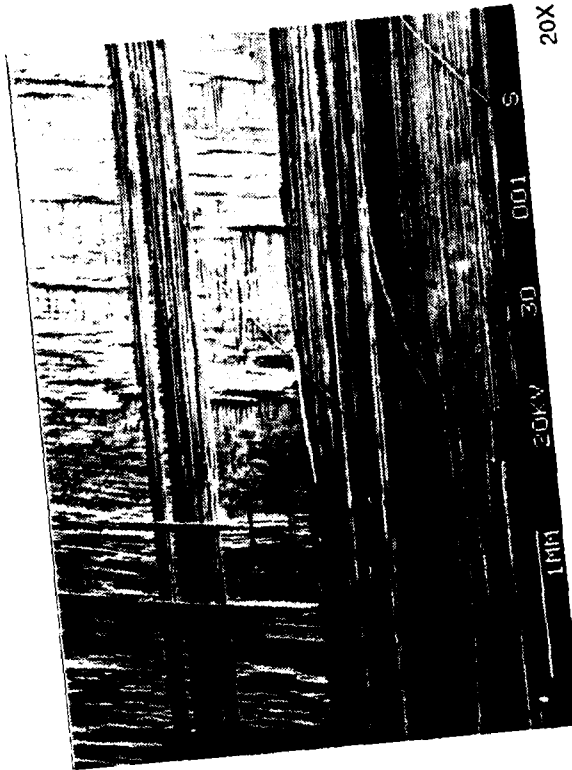
Figure 3.4-2. SEM Fractographs of Interlaminar Mode I Tension, Room Temperature, 0/90 Fracture in AS-4/3501-6

Interlaminar Mode I Tension. Optical examination revealed a smooth, reflective surface. SEM fractography revealed rivermarks and resin microflow in the matrix rich areas between plies indicating propagation in a direction consistent with the mechanically induced crack direction (Fig. 3.4-2). Fiber/matrix adhesion was good.

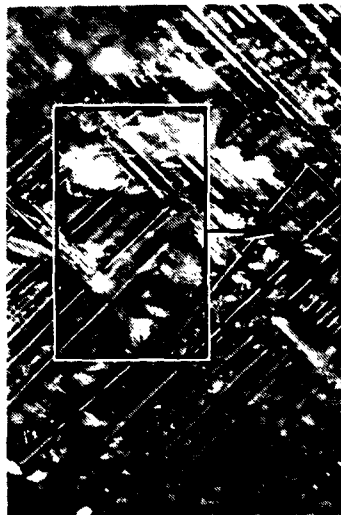
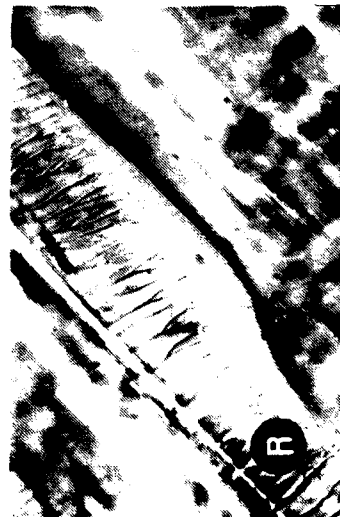
Figure 4.4-14. Optical Photomicrographs of the Open Hole Tension Fracture Surface, ± 45 Degree Layout, Large K_I

In the large K_t , ± 45 degree layup specimen, visual observation revealed an elongated hole in the loading direction. This hole was caused by loading the ± 45 degree ply layup in 0 degree tension. The specimen did not produce a translaminal fracture as it would have with a 0/90 degree ply layup. Rather, there were two fractures, originating from the sharp radius of the hole and propagating in opposite directions to one another. Three locations were examined to determine the fracture modes and origins (Fig. 4.4-13). Removing the delaminated surface ply revealed rivermarks in two locations indicating the crack propagated toward the outer edge of the specimen. The cracks initiated near a third location, under Mode II shear (Fig. 4.4-14).

Location A —
near the outer edge

Location B —
at the center

Location C —
near the hole edge

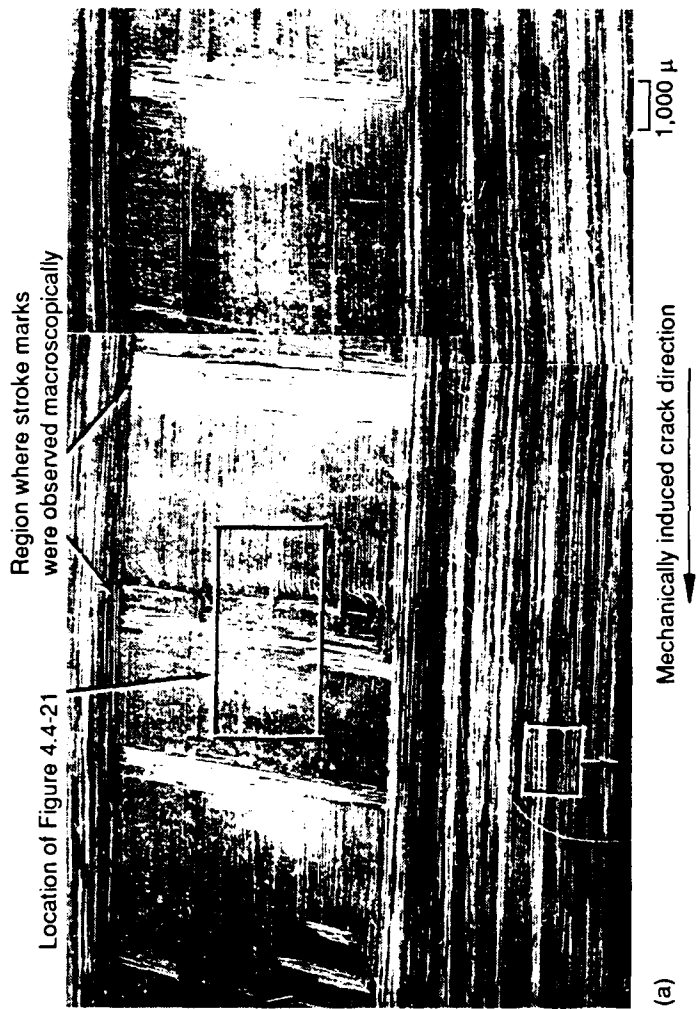
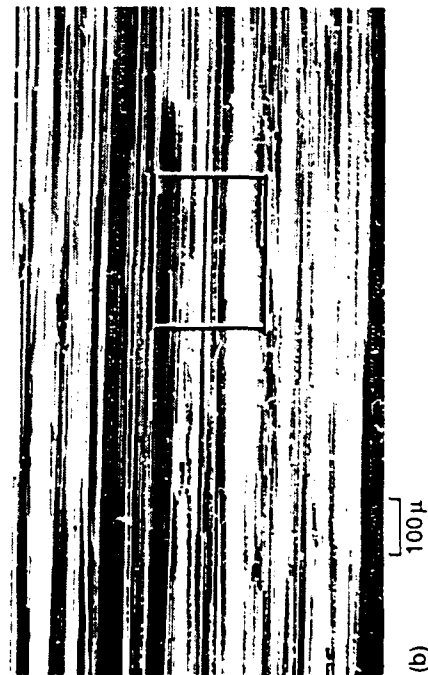
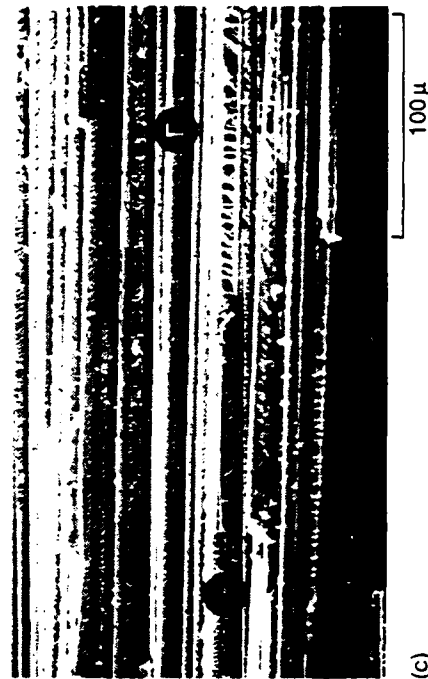
Figure 4.4-20. SEM Fractographs of Interlaminar Mode I Tension, RT/Dry Creep Fracture

SEM fractographs were taken of the three regions of fracture, including the location of the crack arrest (Fig. 4.4-20). The fracture topography was smooth with distinct rivermarks just prior to the periodic crack arrest; after reinitiation of the crack, the fracture appeared uneven with very fine rivermarks (Fig. 4.4-21).

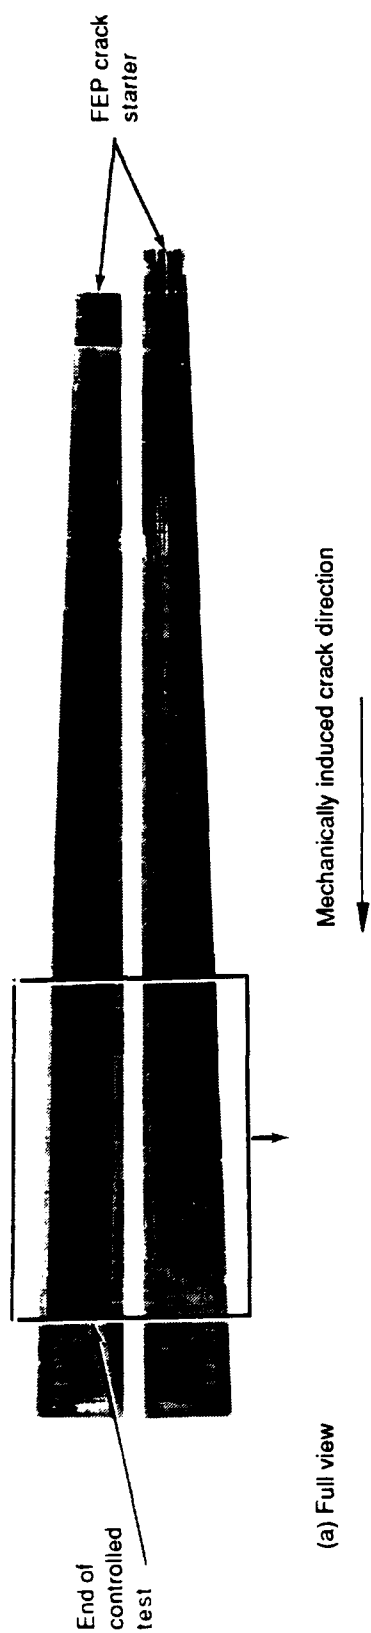
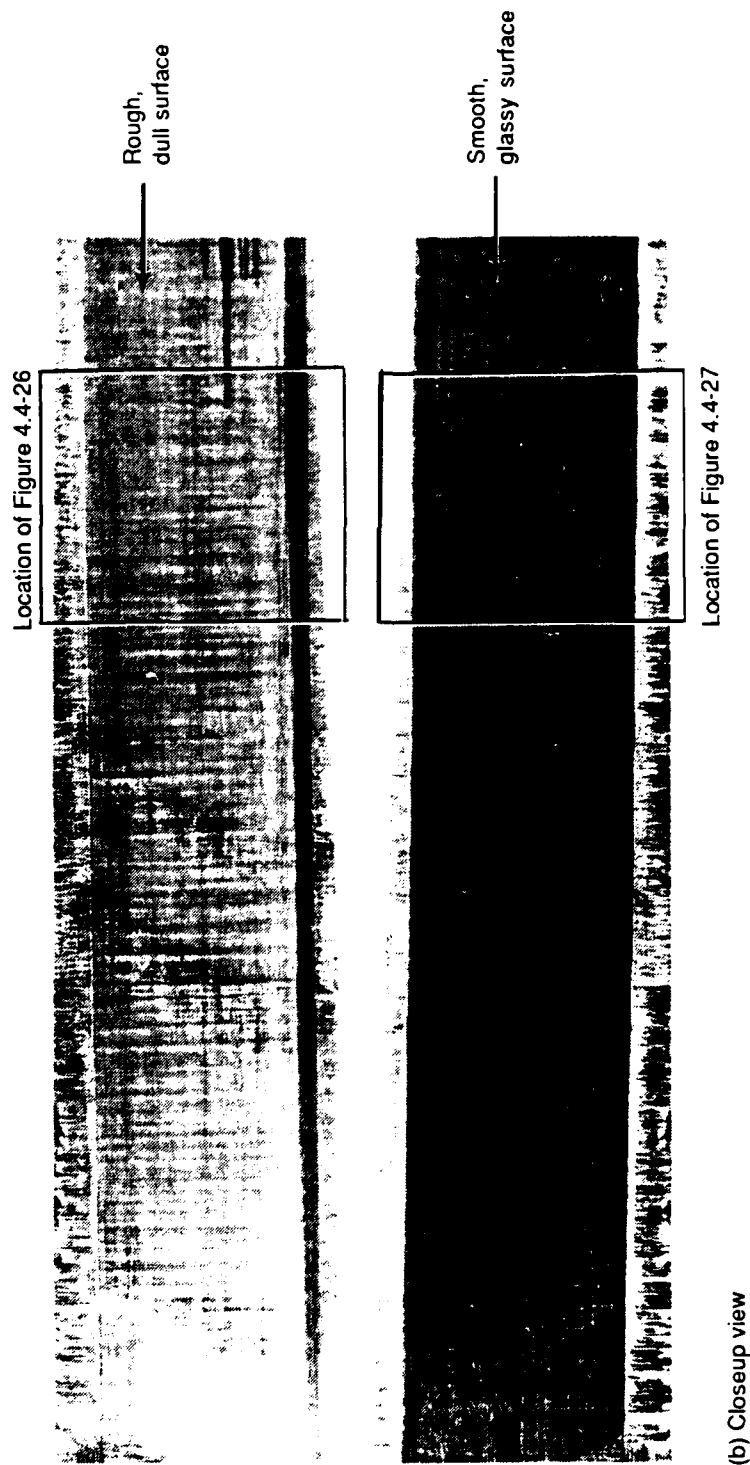
Figure 4.4-25. Photomicrographs of Interlaminar Mode II Shear, RT/Dry Creep Fracture

Interlaminar Mode II Shear, RT/Dry. Visually, the mating fracture surfaces looked somewhat different: one surface smooth and glassy, the other rough and dull (Fig. 4.4-25). Crack arrest marks were observed on the fracture surfaces at the ends of the specimen and at the center. SEM fractographs revealed that the glassy surface consisted largely of scallops (with some hackles) (Fig. 4.4-26) and the rough surface exhibited mainly hackles (with some scallops) (Fig. 4.4-27).

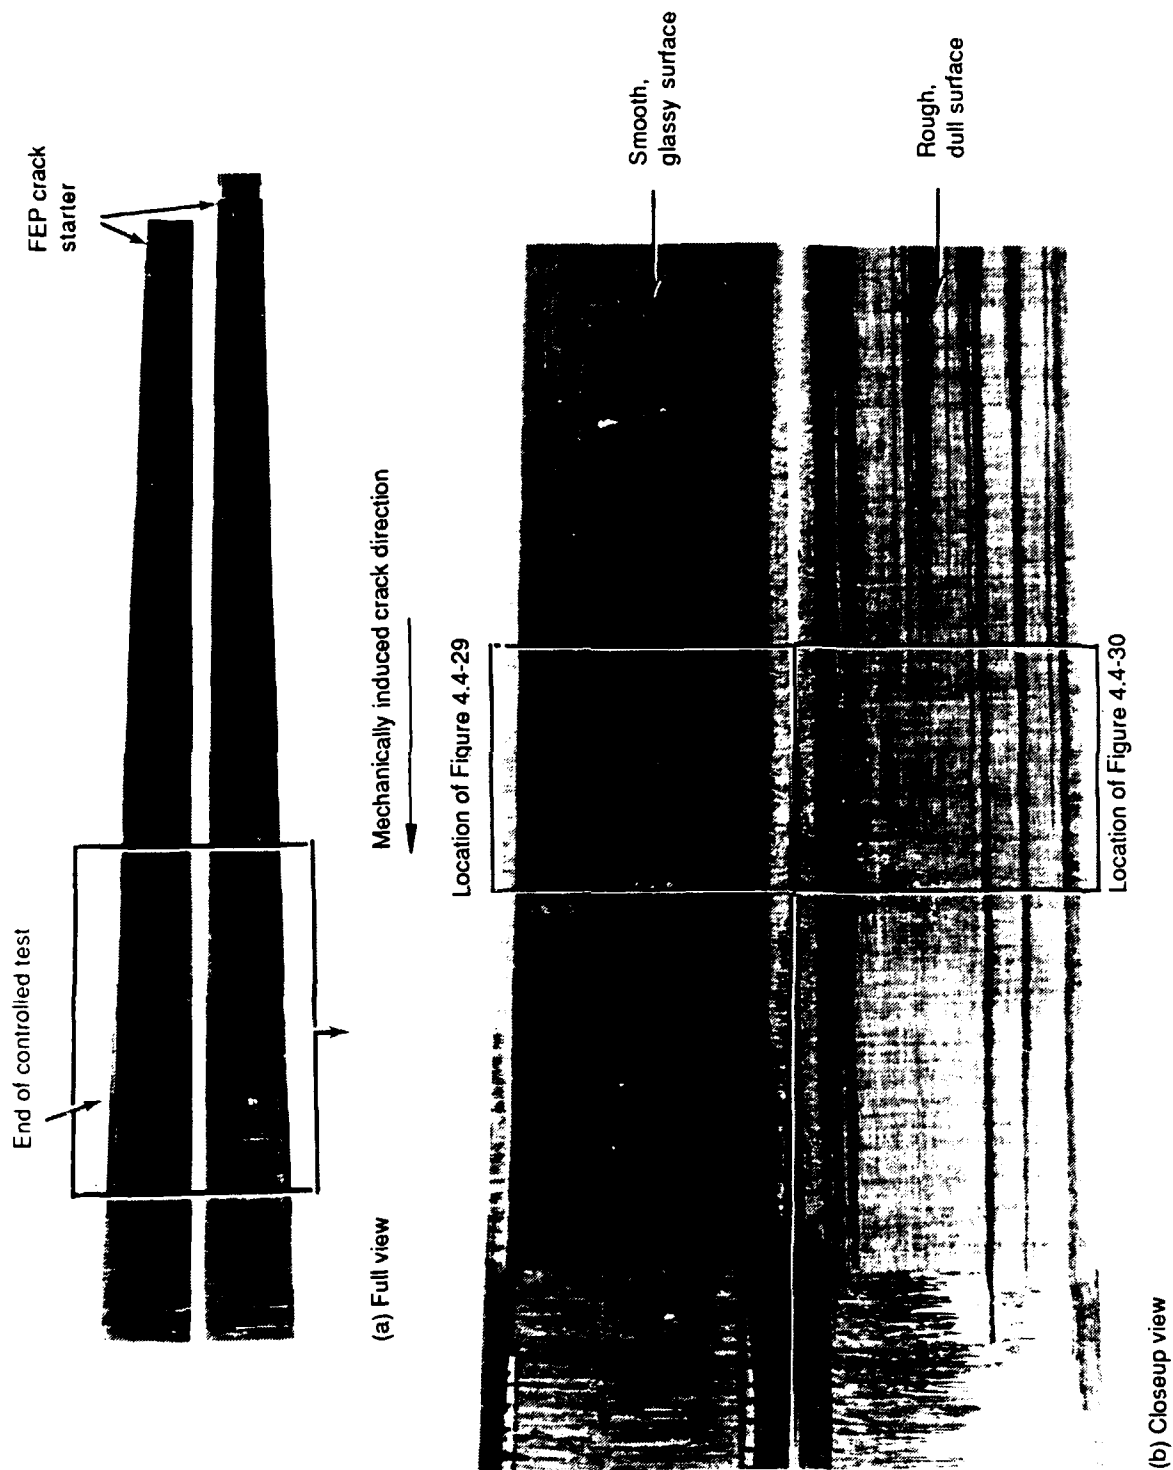
Figure 4.4-28. Photomacrographs of Interlaminar Mode II Shear, 270 F/Dry Creep Fracture

Interlaminar Mode II Shear, 270°F. Visual examination revealed a fracture with smooth and glassy surface on one of the mating sides and rough and dull on the other (Fig. 4.4-28). This was similar to the fracture surfaces created at room temperature. The glassy surface exhibited mostly of scallops (with some hackles) (Fig. 4.4-29), and the

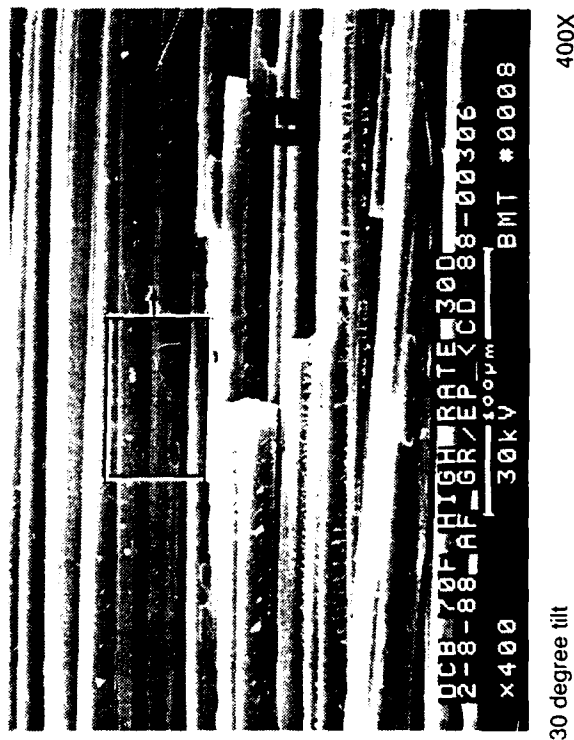
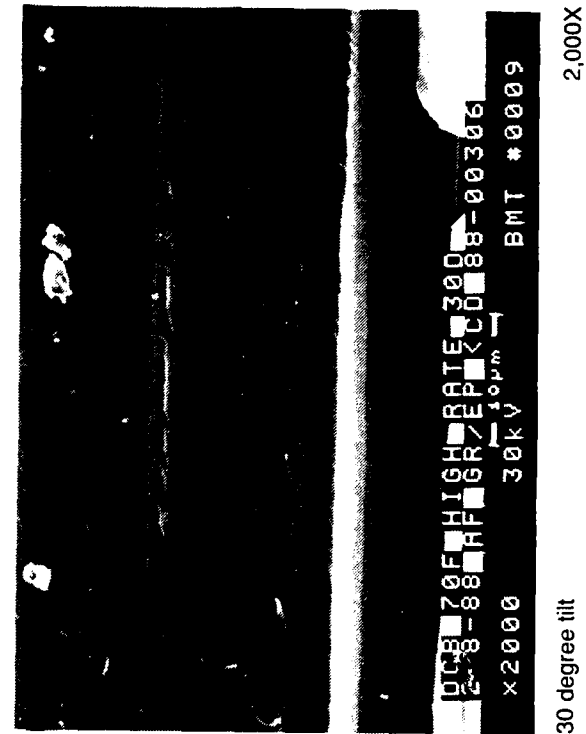
Figure 4.4-32. SEM Fractographs of Interlaminar Mode I Tension, High Rate, Room Temperature Fracture (Region I)

SEM analysis showed that Region I experienced a lower energy fracture than Region II, as evidenced by its rougher surface and more mixed mode fracture (Fig. 4.4-32). This may be a result of the initially delaminated portion driving the crack at a higher rate. There were also many fiber splinters in Region II (Fig. 4.4-33).

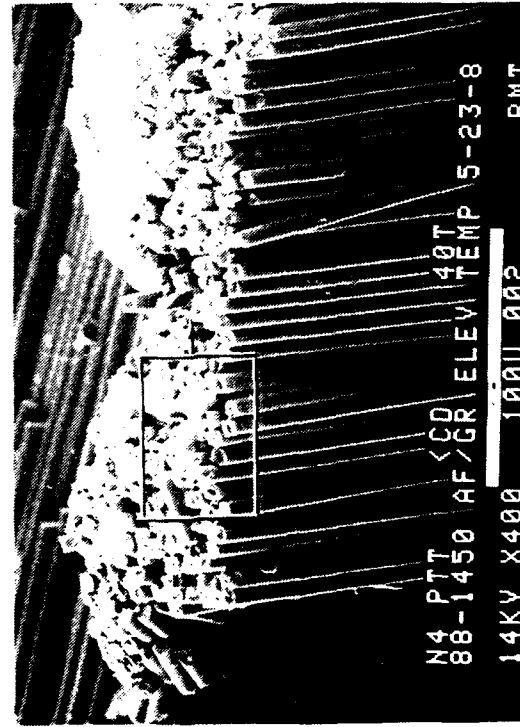
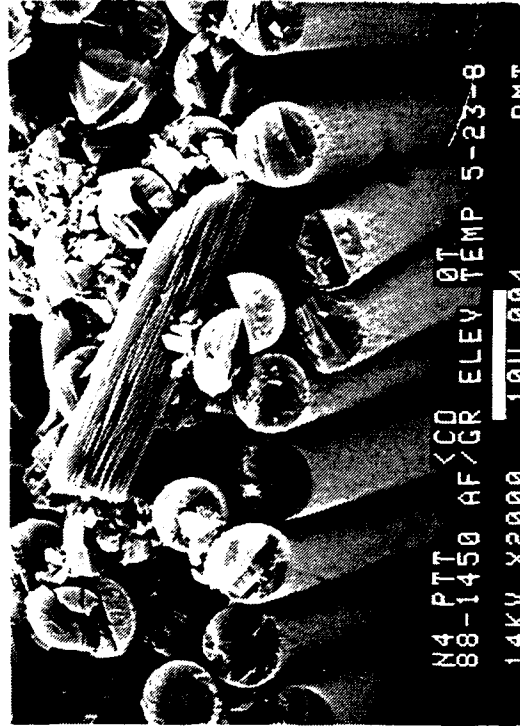
Figure 4.4-44. SEM Fractographs of Elevated Temperature, Translamellar Tension Fracture

The bare fibers were especially visible in the SEM fractographs. Radial patterns typically seen under translaminar tension failure mode were observed on the fiber ends prior to the flame test was no longer present afterwards (Fig. 4.4-44). Instead, the fibers showed extensive cracking on their end surfaces.

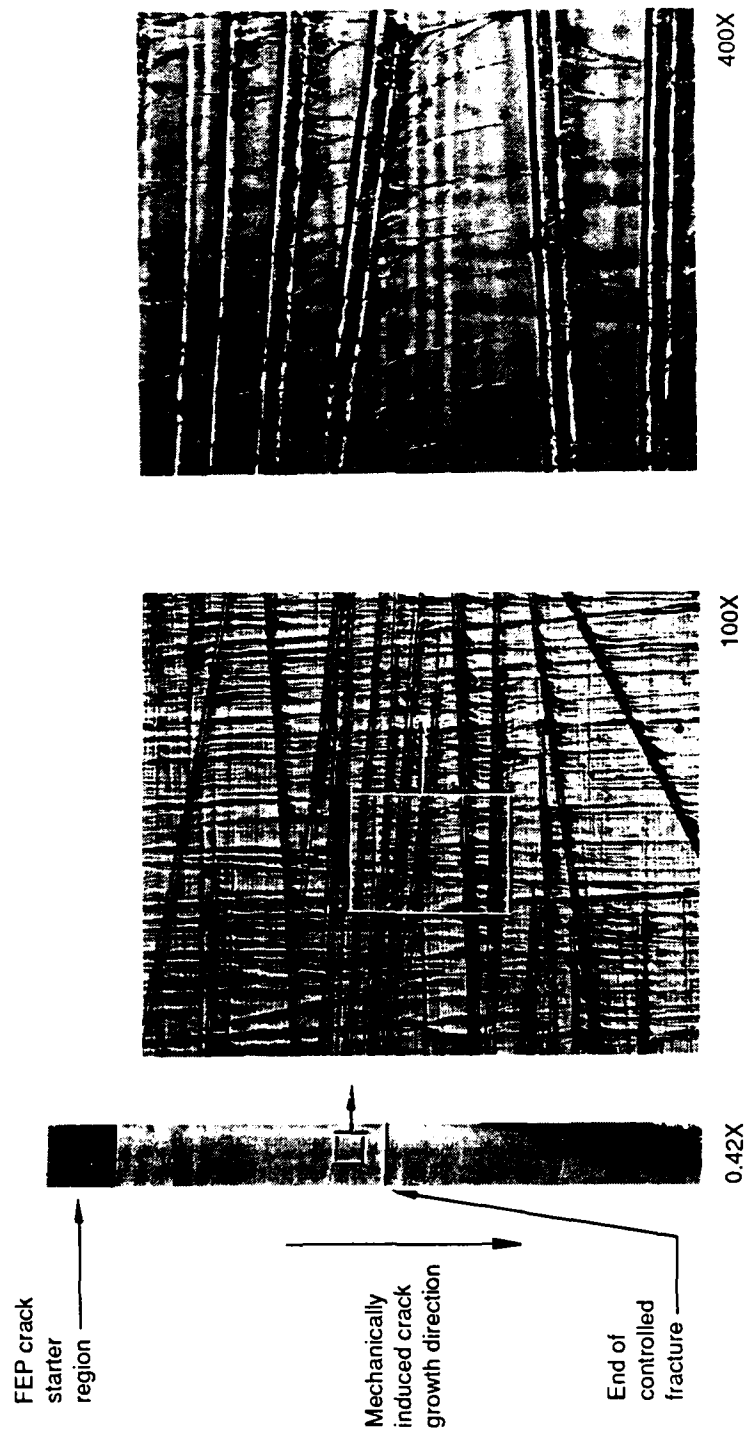
Figure 4.4-46. Optical Photomicrographs of Interlaminar Mode I Tension, 0/90 Fracture After Exposure to Humidity (160 F)

Interlaminar Mode I Tension. Visual observation of the water immersion and high humidity specimens revealed smooth glassy fracture surfaces as commonly seen in interlaminar Mode I tension specimens at RT/dry conditions (Fig. 4.4-45 and 4.4-46). At higher magnifications under the optical microscope, rivermarks and resin microflow were seen. Work done in the previous contract, C-5010, determined that these features reveal an overall crack propagation direction. However, it was noted that the rivermarks in these specimens were not as distinct as they were in the RT/dry specimens (Fig. 4.4-47 and 4.4-48). In general, the humidity and water immersion specimens exhibited nearly identical fracture characteristics.

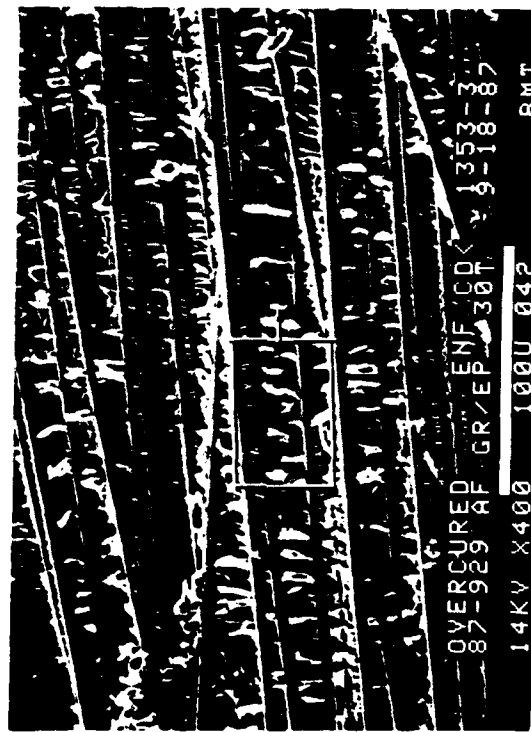
Figure 4.4-63. Sem Fractographs of Interlaminar Mode II Shear, 0/90 Fracture of Overcured Specimen

The SEM analysis revealed a typical RT/dry fracture surface with many hackles between the fibers. The hackles were scattered along the fracture surface without any orderly arrangement (Fig. 4.4-63).

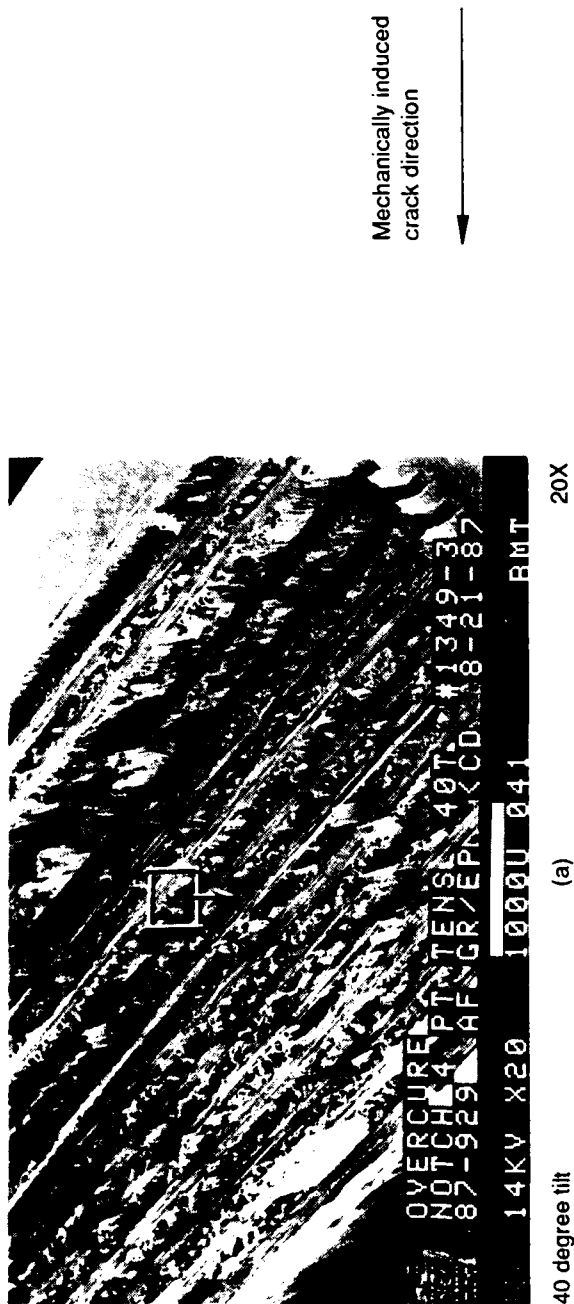
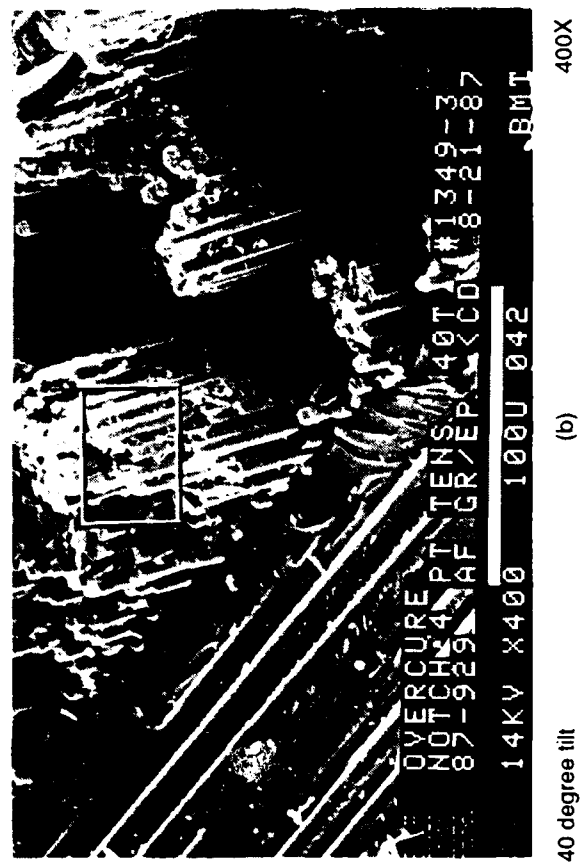
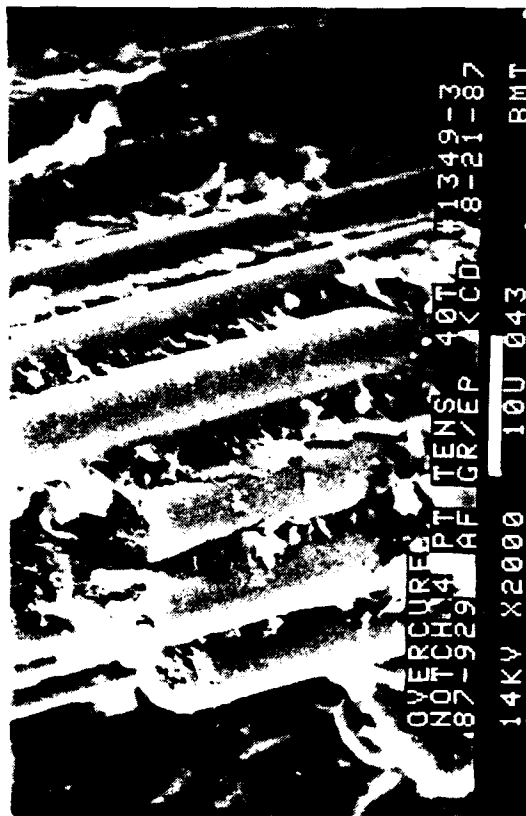
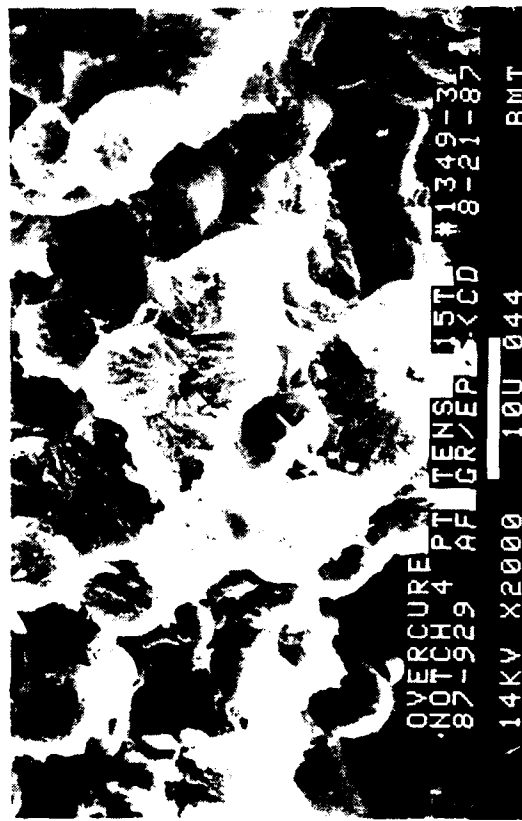
Figure 4.4-64. SEM Fractographs of Translamellar Tension Fracture of Overcured Specimen

Translaminar Tension. Visual and optical observations revealed a typical translaminar fracture with protruding fibers. The fiber/matrix interface showed good adhesion. The radial patterns on the fiber ends were clearly seen and the crack direction was easily determined (Fig. 4.4-64).

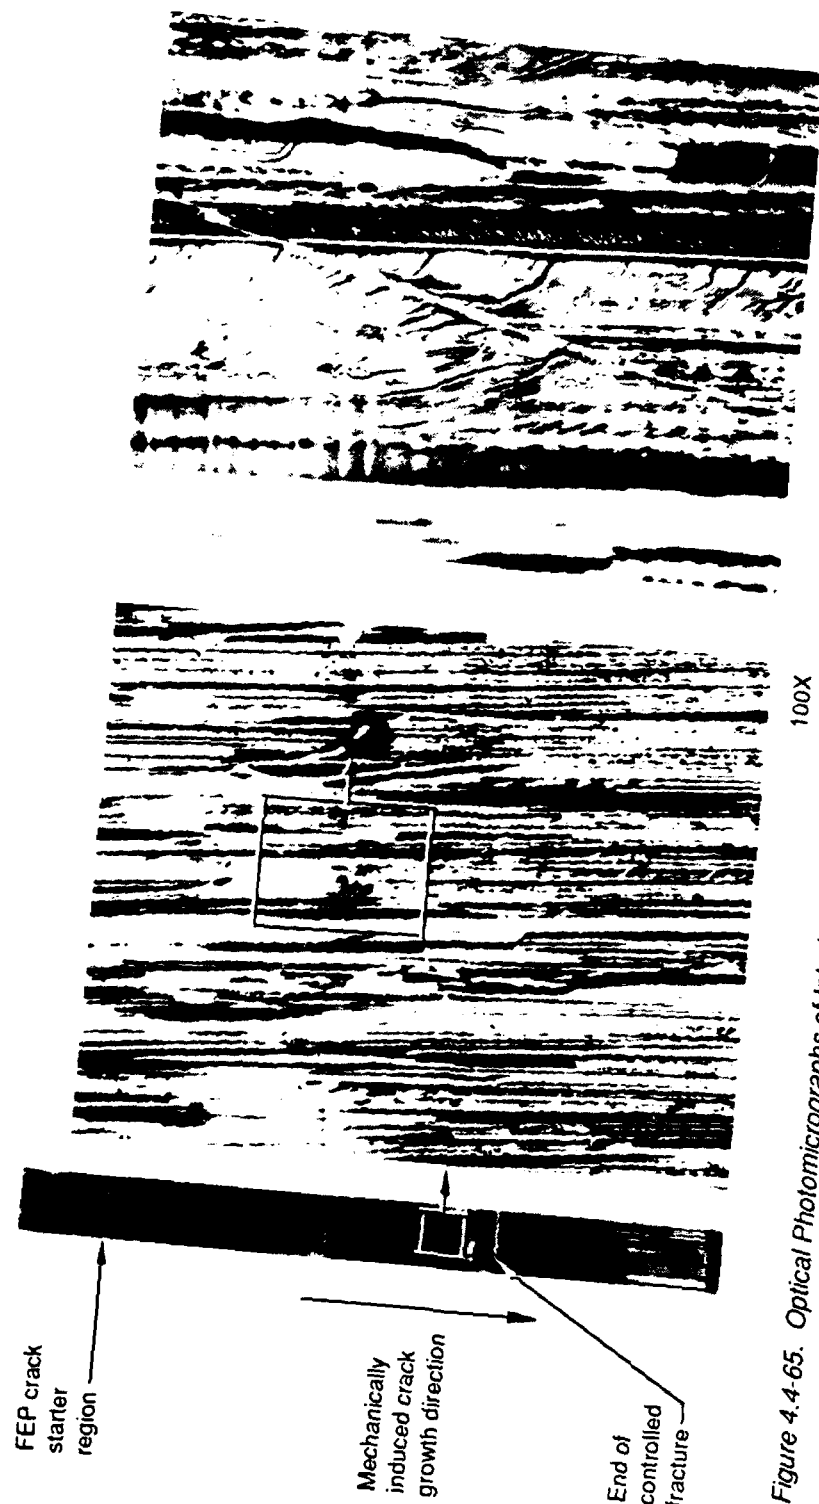
Figure 4.4-65. Optical Photomicrographs of Interlaminar Mode I Tension, 0°/90° Fracture of High Resin Content Specimen

Interlaminar Mode I Tension. Visual observation of the fracture surface revealed a typical smooth, glassy fracture commonly seen in interlaminar Mode I tension specimens at RT/dry condition as shown in Figure 4.4-65. At higher magnification, rivermarks and resin microflow were seen. The SEM analysis revealed a fracture surface with rivermarks as typically observed in RT/Dry specimens (Fig. 4.4-66).

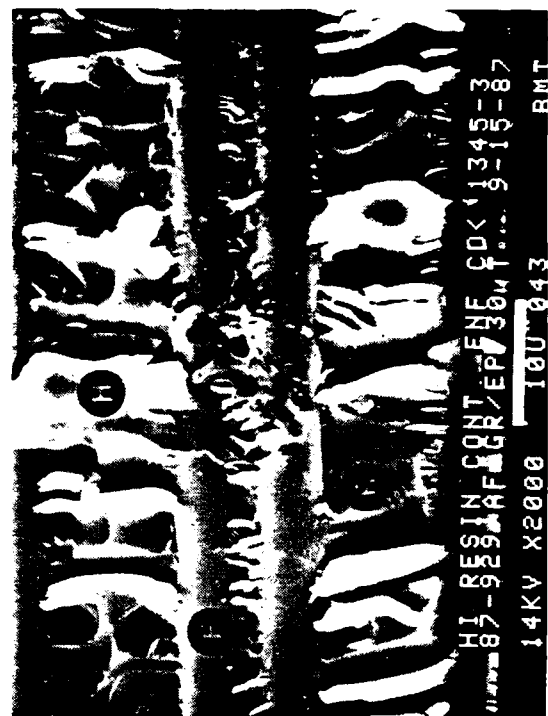
Figure 4.4-68. SEM Fractographs of Interlaminar Mode II Shear, 0/90 Fracture of High Resin Content Specimen

The SEM analysis revealed a fracture surface typically observed in RT/dry specimens (Fig. 4.4-68).

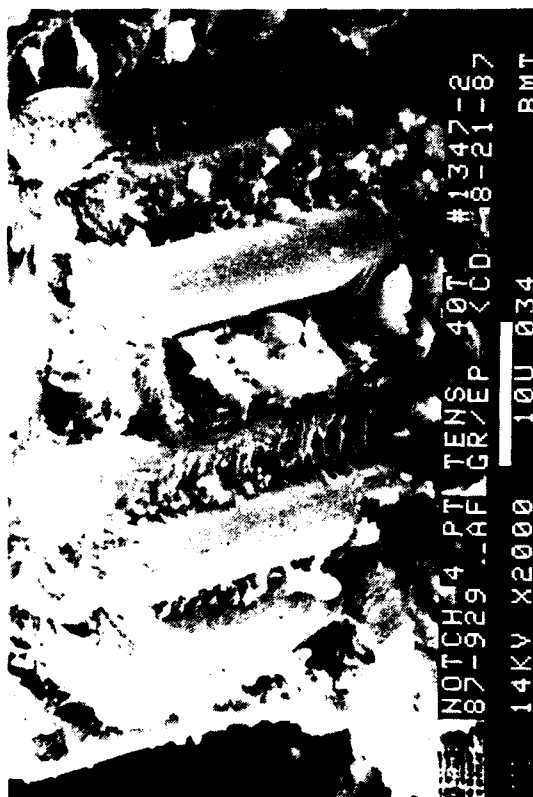
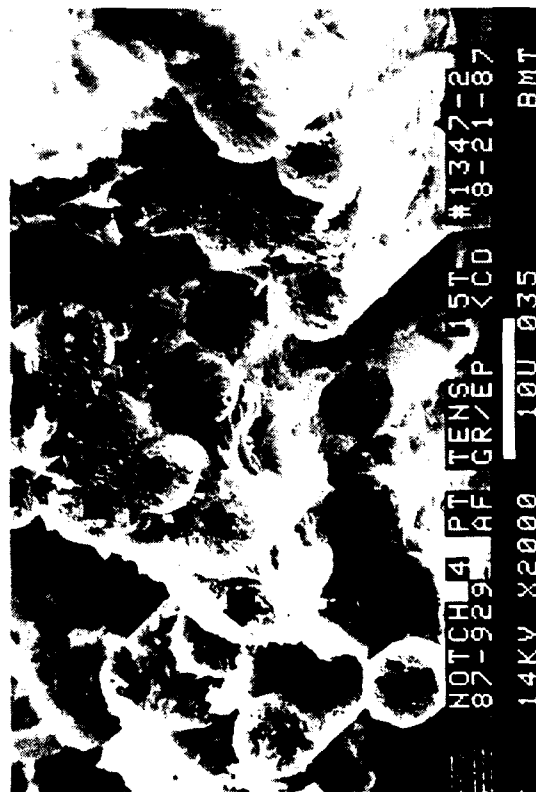
Figure 4.4-69. SEM Fractographs of Translamellar Tension Fracture of High Resin Content Specimen

Translaminar Mode I Tension. Visual and optical observations revealed large fiber pullout regions due to uneven distribution of the added resin film. SEM fractograph showed a cohesive resin fracture at the fiber/matrix interface due to the excessive resin content. The radial patterns on the fiber ends were clearly seen (Fig. 4.4-69).

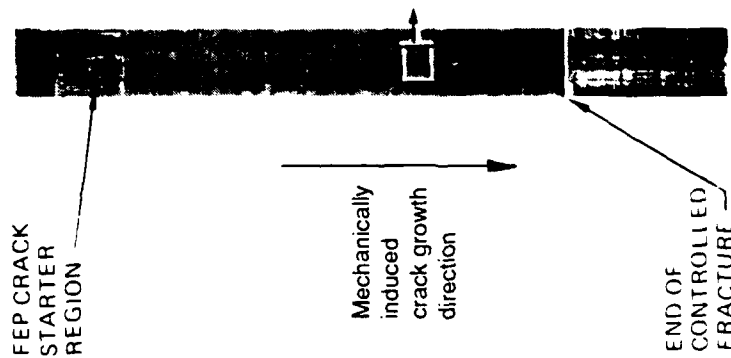
Figure 4.4-70. Optical Photomicrographs of Interlaminar Mode I Tension, 0/90 Fracture of Low Resin Content Specimen

Interlaminar Mode I Tension. Visual observation of the fracture surface revealed the smooth, glassy fracture surface typical of interlaminar Mode I tension specimens at RT/dry. The only noticeable difference was the fiber splinters resulting from the insufficient degree of resin wet-out at the fiber/matrix interface. At higher magnification under the optical microscope, a typical region of low resin content showed lack of fracture features such as rivermarks to indicate the overall crack direction (Fig. 4.4-70).

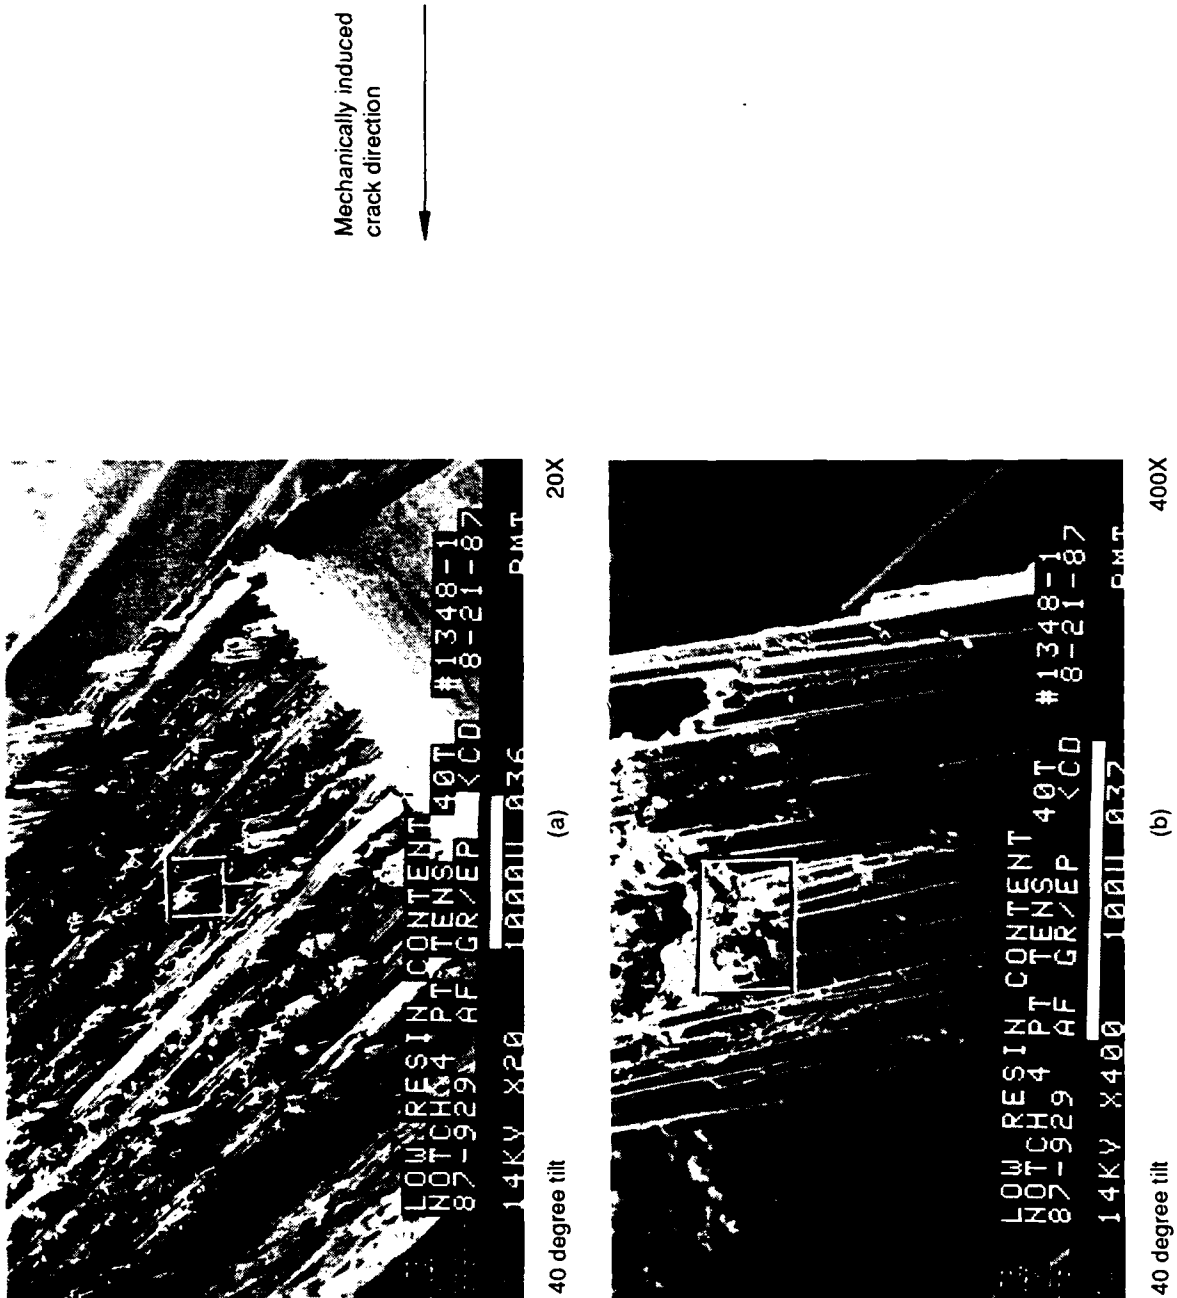
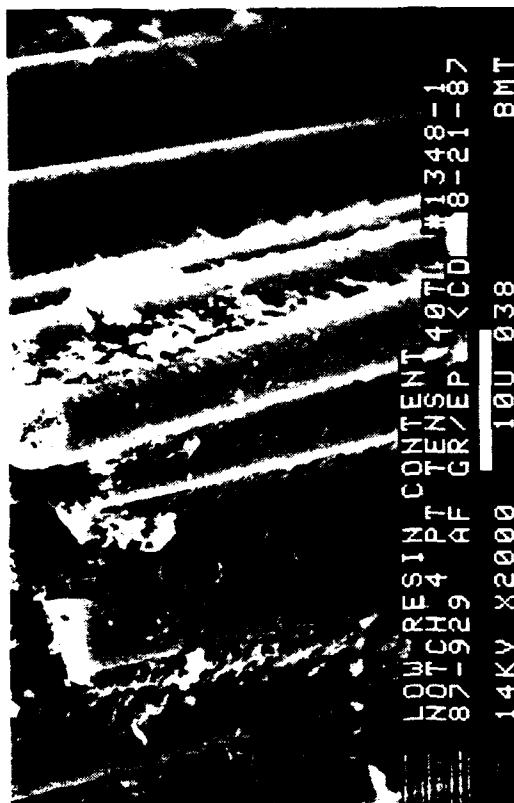
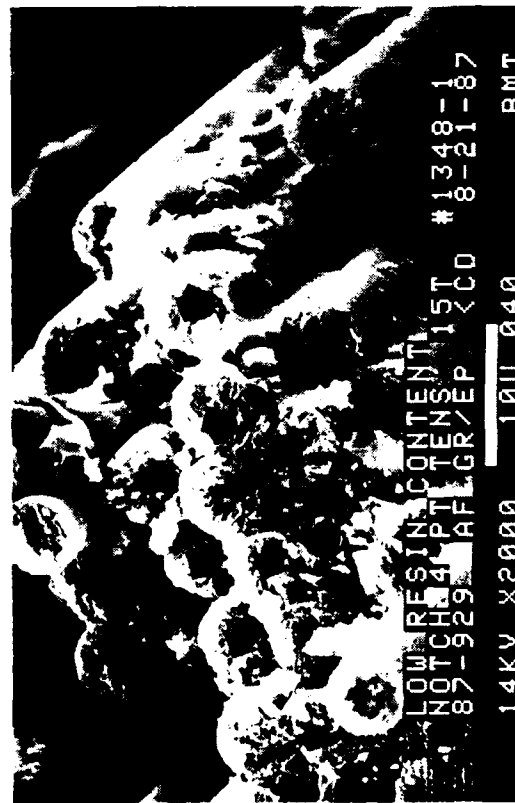
Figure 4.4-74. SEM Fractographs of Translamellar Tension Fracture of Low Resin Content Specimen

Translaminar Tension. Visual, optical, and SEM observations revealed localized fiber pullouts; the protruding fibers were unevenly distributed on the fracture surface. The fiber/matrix adhesion seemed poor as evidenced by the lack of resin fracture along the sides of the fibers. However, the radial patterns essential for determining the crack direction were clearly seen (Fig. 4.4-74).

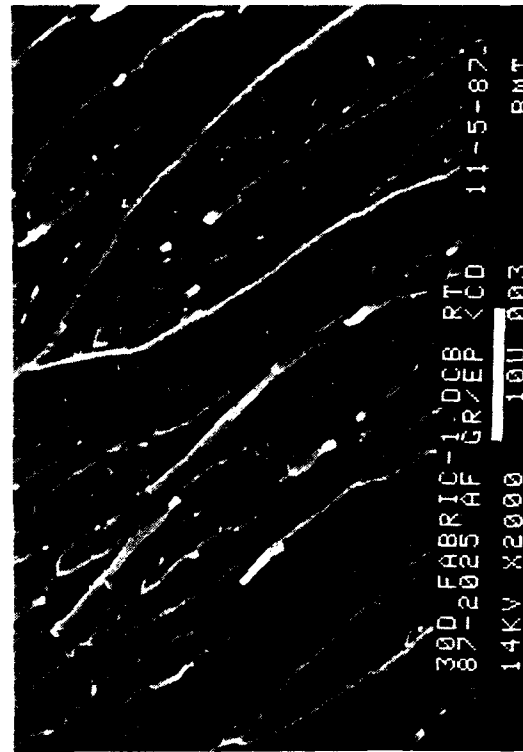
Figure 4.4-76. SEM Fractographs of Interlaminar Mode I Tension, Room Temperature, Fabric Fracture

SEM analysis confirmed the optical results. However, because the rivermarks in a single region are not always consistent with those in other regions, several resin-rich regions should be observed before making any conclusions on the crack propagation direction (Fig. 4.4-76).

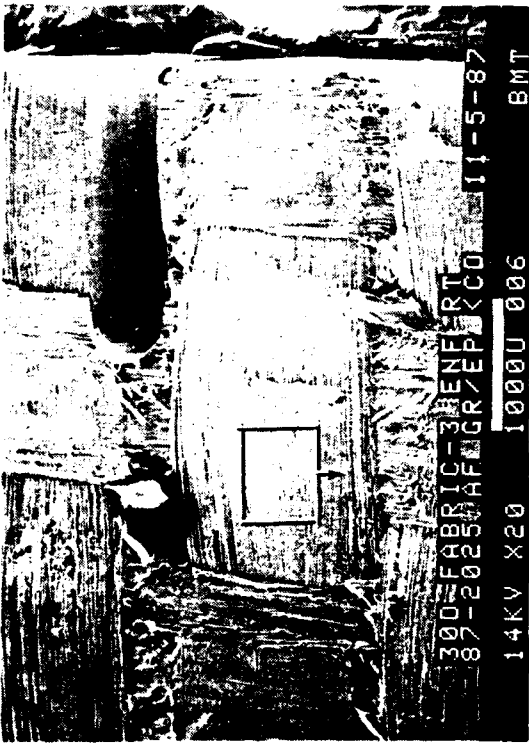
Figure 4.4-78. SEM Fractographs of Interlaminar Mode II Shear, Room Temperature, Fabric Fracture

SEM analysis confirmed the optical results. The hackles were in various shapes and sizes (Fig. 4.4-78); as with the fracture surface created with a tape layup, these hackles are not indicators of crack propagation direction.

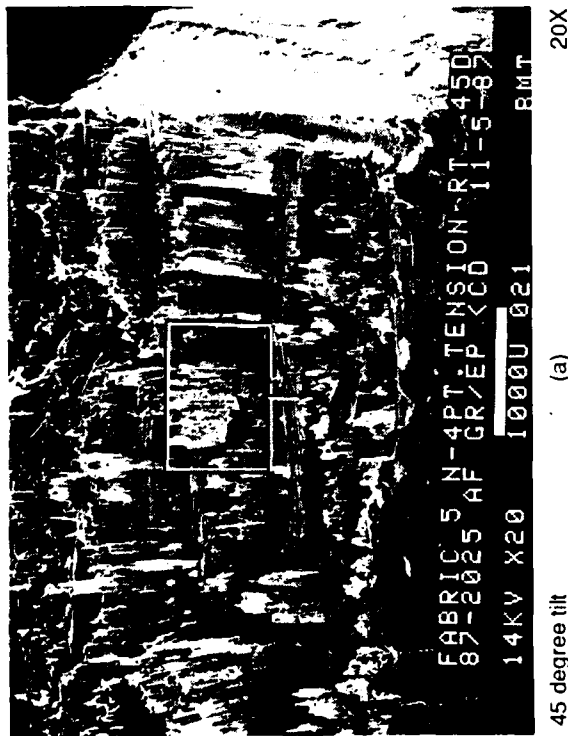
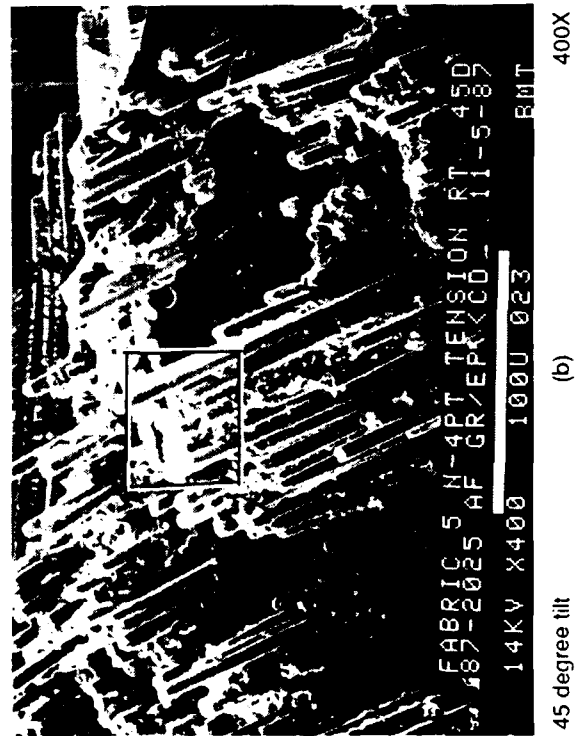
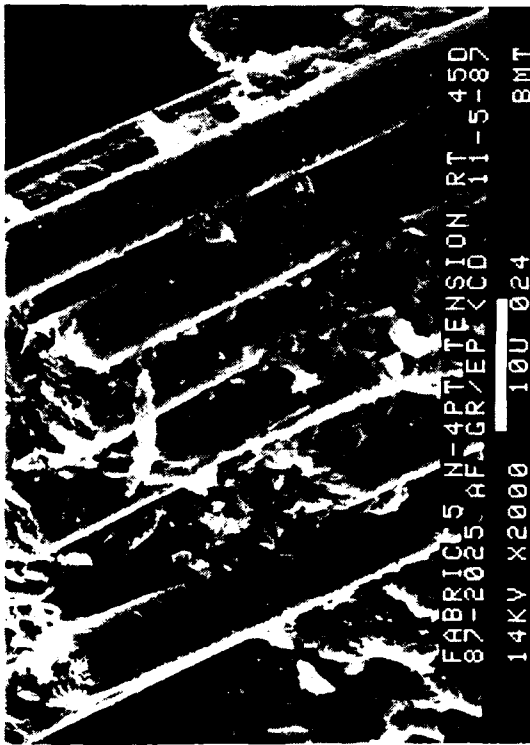
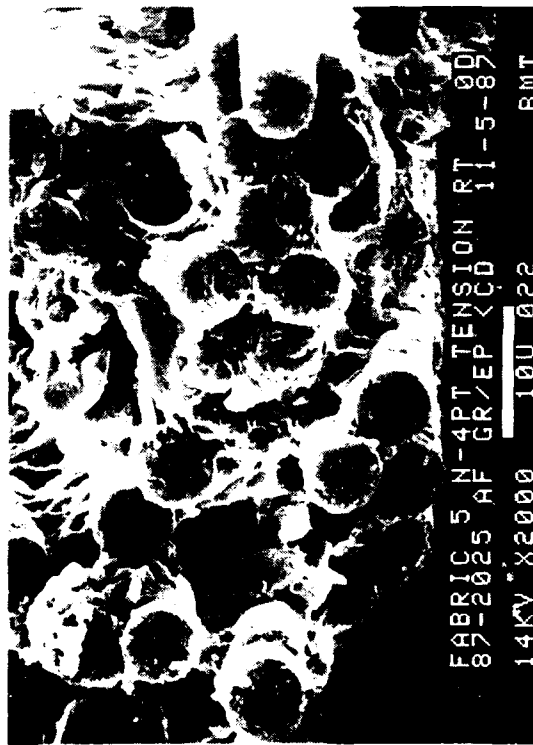
Figure 4.4-79. SEM Fractographs of Translaminar Tension, Room Temperature, Fabric Fracture (Concluded)

SEM analysis showed resin-rich regions between protruding fiber bundles. The fiber/matrix adhesion was good. Radial patterns on the fiber ends were observed (Fig. 4.4-79).

45 degree tilt (c) Typical fracture along the fibers 2,000X

0 degree tilt (d) Illustration of crack mapping using the radial patterns on the fiber ends 2,000X
